**IN THE UNITED STATES DISTRICT COURT
NORTHERN DISTRICT OF INDIANA
FORT WAYNE DIVISION**

Case No. 1:21-cv-108-HAB-SLC

**DEFENDANT COE HEATING & AIR CONDITIONING, INC.’S DESIGNATION OF
EVIDENCE SUPPORTING COE HEATING & AIR CONDITIONING, INC.’S MOTION
FOR SUMMARY JUDGMENT**

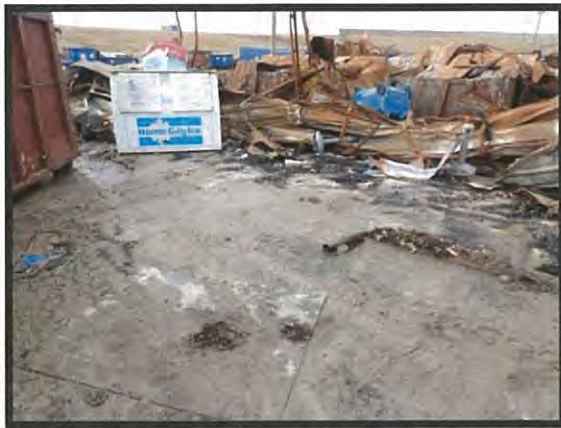
View of southeast corner with evident track marks and cleared debris

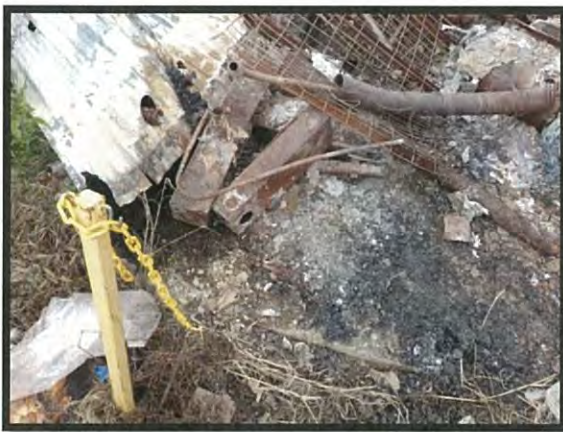
View depicting electrical components within area of interest

conductors, circuit breaker panels, lighting fixtures, electric fans and other building electrical components not being examined, evaluated or analyzed. None of these aforementioned items were collected and removed from the fire scene as evidence for further analysis. It is my opinion that these items remain potential ignition sources which were not ruled out as being the cause of the fire. Other identified potential ignition sources include discarded and or improperly disposed of smoking materials. I observed and documented smoking materials in the form of cigarette packaging and cigarette butts within a melted down garbage can located at floor level on the interior of the south 1/4 of the building and immediately below the north infrared gas-fired heater. Additionally, discarded cigarette butts were observed and documented on the ground and in close proximity to the exterior of the southeast corner of the subject building. It is my opinion that smoking materials improperly discarded or disposed of are unable to be eliminated as being a potential cause for this fire loss.

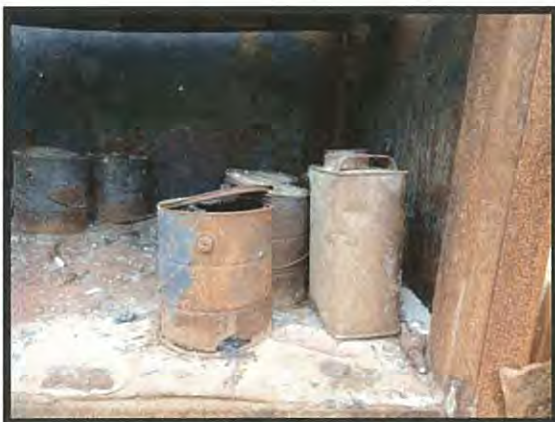
View of containers in metal storage cabinet

It is my opinion that the Forensic and Scientific Testing (FAST) Certified Laboratory Report indicating the presence of medium and heavy petroleum distillates, can be explained as being expected to be present or common to the area in the subject work shop area and subject building. This is based on the documented presence of asphalt shingles and tar paper, lens wipe packets, other solvents and flammable liquids. There were several containers observed and documented which possibly contained flammable liquids. Additionally, it is my opinion that given the collapse of the roof, ceiling and all unburned components ultimately resting on or near floor level, with the tens of thousands of gallons of water utilized to extinguish the fire, any liquids within the area of fire damage would have become dispersed or floating to other areas than they were originally. This clearly caused cross-contamination.

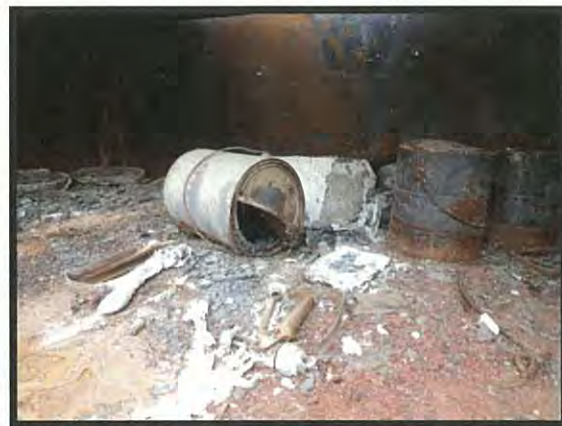
View of containers in metal storage cabinet

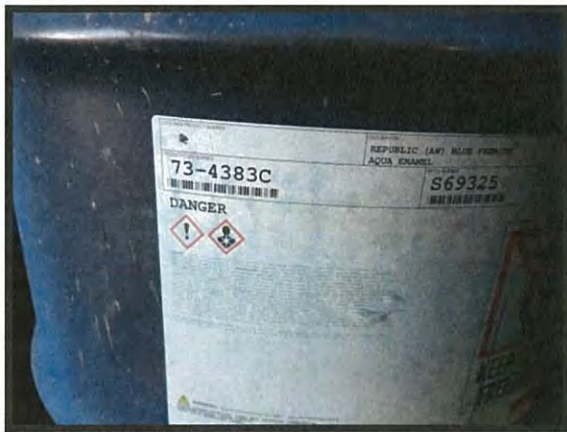
Drum of blue paint from subject site

flammable finish. Additionally, it was noted and observed that throughout the subject building and area of interest, that there was evidence of unburned, pristine blue paint remnants in the form of chunk pieces. These pieces and remnants were throughout and completely unburned or consumed by the fire. It is also my opinion that there was no build up or even slight presence of blue paint on any of the three infrared gas-fired heaters removed from the fire scene.

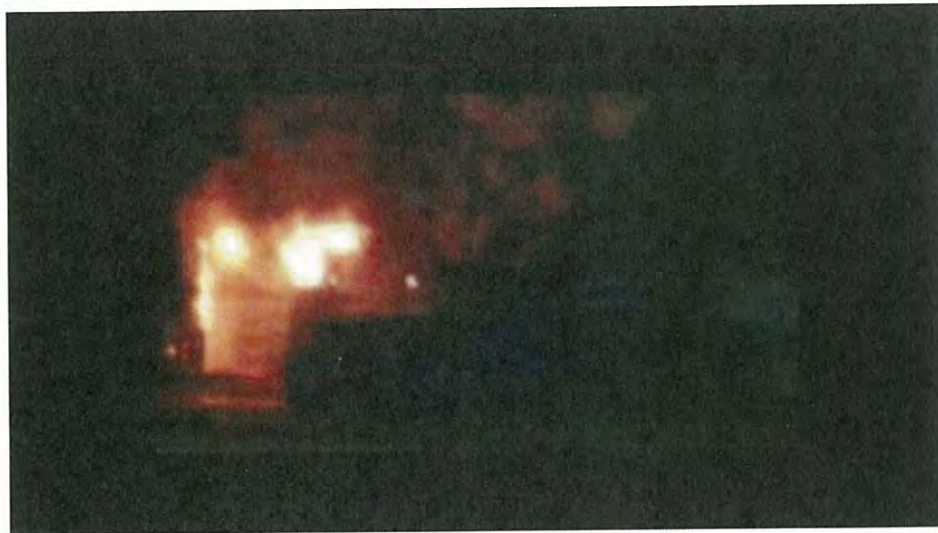
Figure 3: Early witness photograph of fire. Note furthest south bay Storage Room is most heavily involved of the bays, with fire also involving the south, exterior end of the structure.

The first of the below photographs is one of the first known photos to be taken of the fire. It is not known who took the photo, nor at what time. A following side-by-side photographs depict what I believe to be the south end of Building 1, pre-fire and during-fire. The southernmost bay storage room appears to be the most heavily involved of the bays.

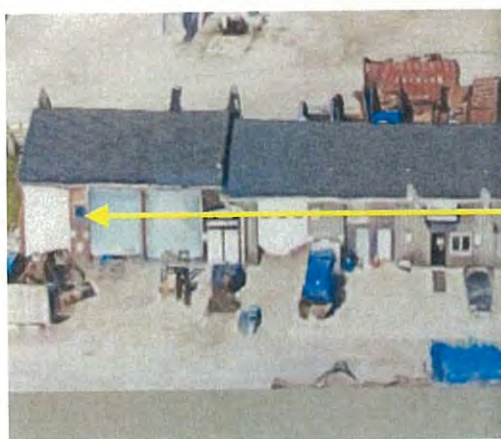
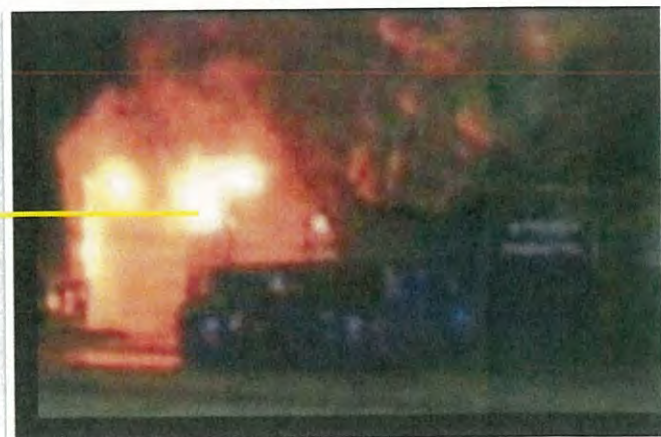
Figure 4: Side-by-side photos, with vent fan window location being identified.

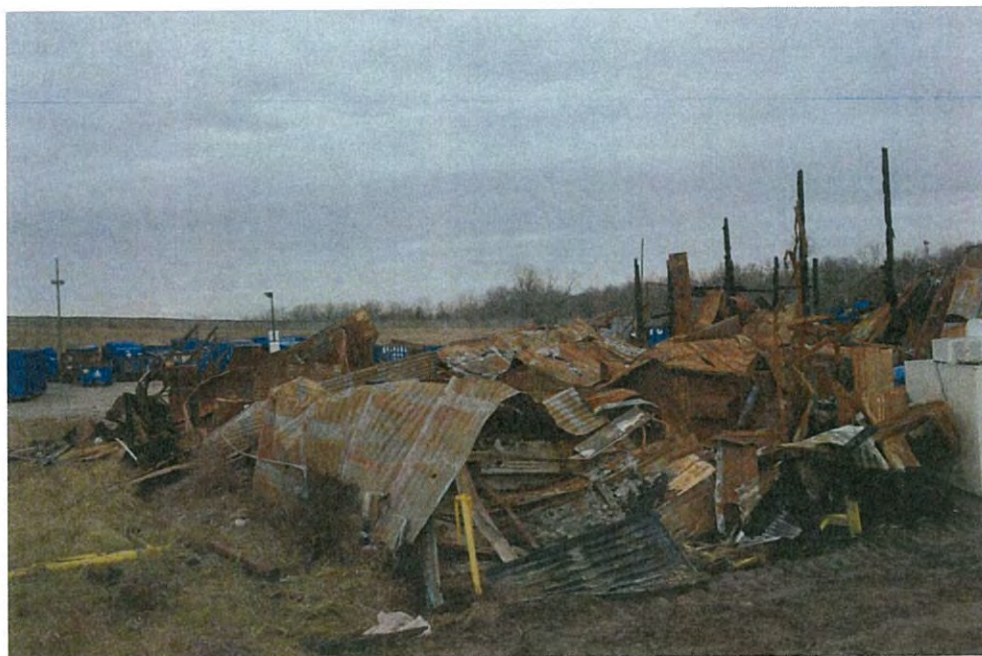
Figure 6 (DSC_8755): View at Southeast corner of structure remains.

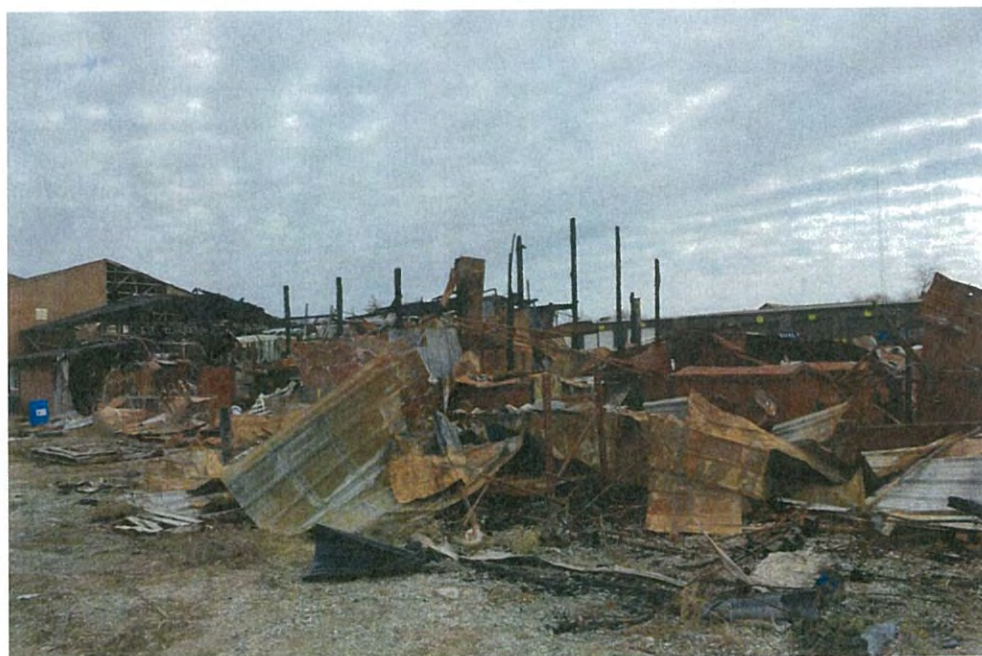
Figure 7 (DSC_8767): View from southwest corner of structure remains.

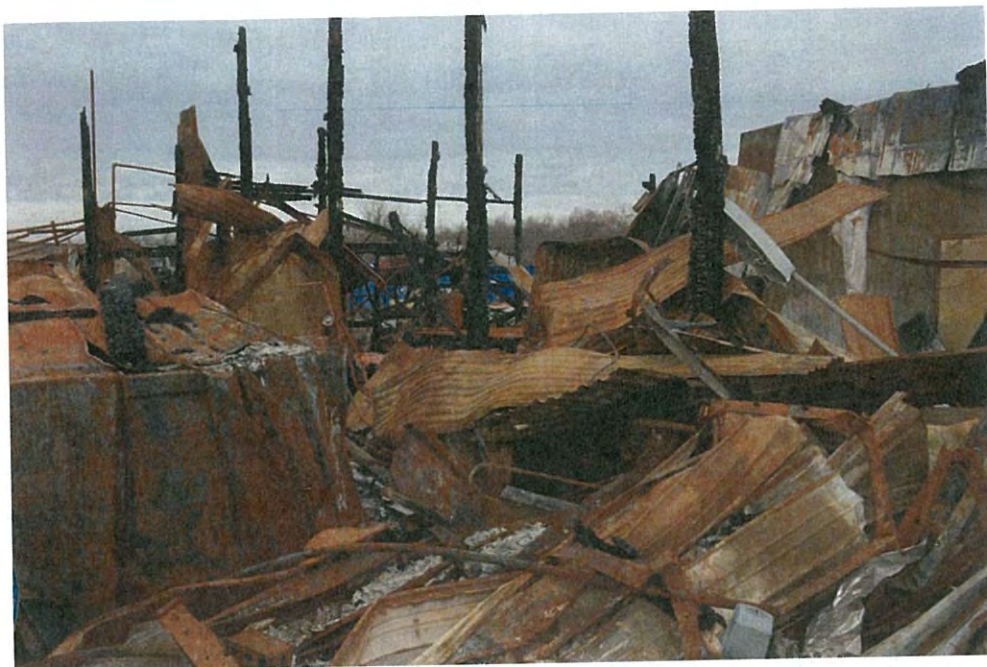
Figure 8 (DSC_8781): View within structure remains, east to west.

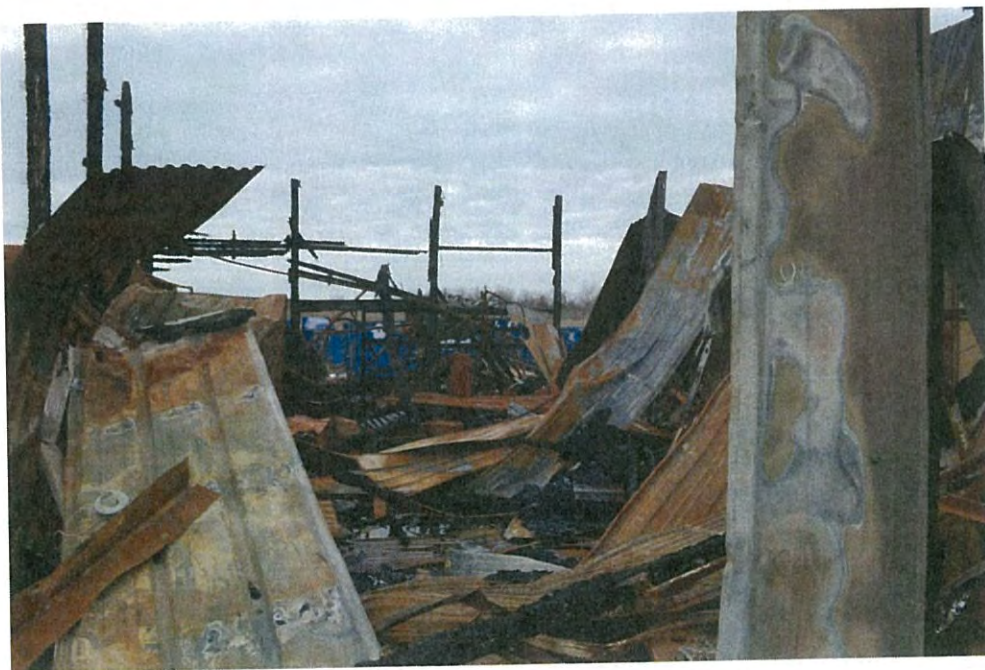
Figure 9 (DSC_8788): View within structure remains, east to west.

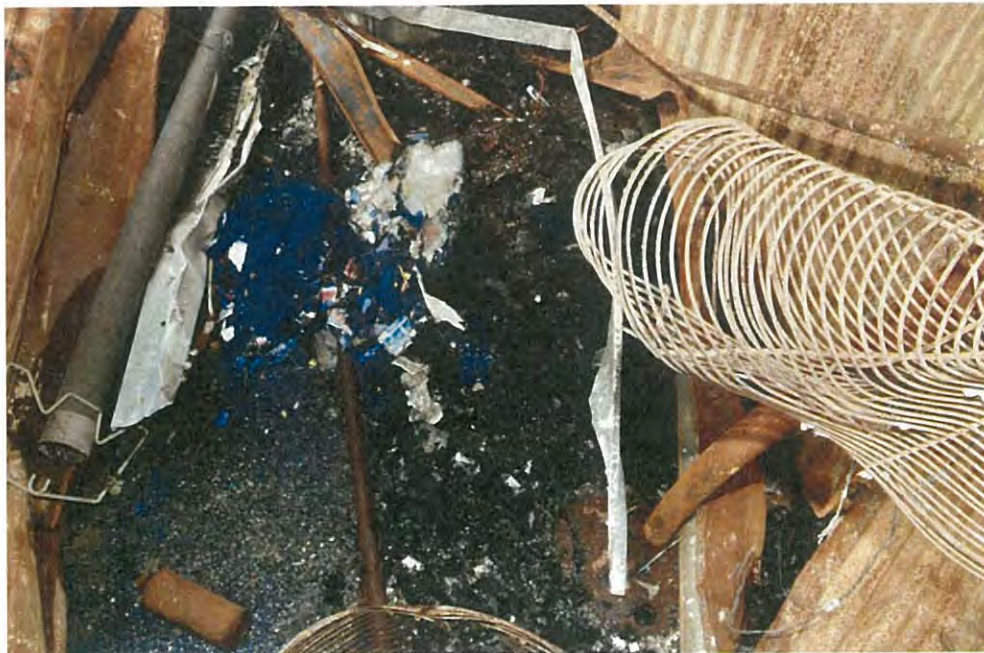
Figure 10 (DSC_8805): Melted garbage container remains among collapsed debris and section of collapsed tube.

During this examination, I documented the presence of an empty cigarette pack among the remains of debris, in a melted garbage container near one of the tube heaters that had collapsed to floor level.

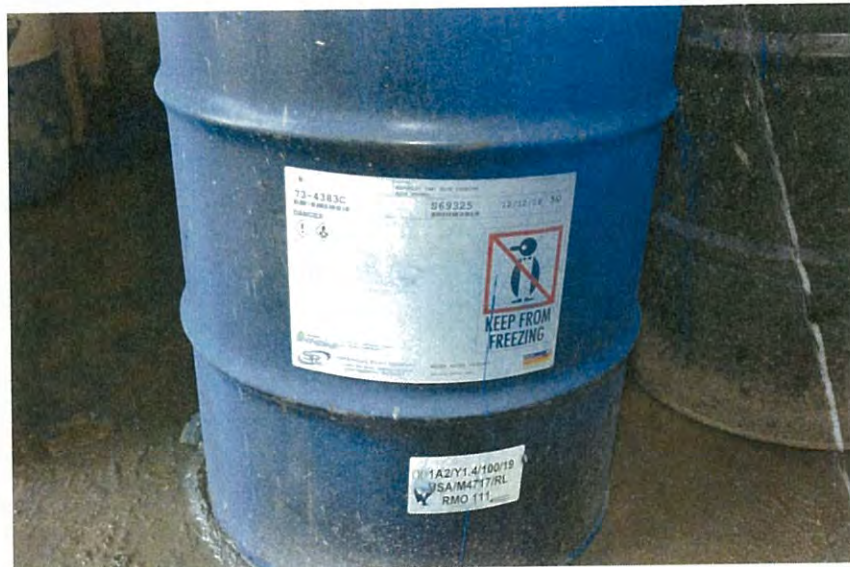
Figure 11 (DSC_8820): Barrel of "Republic Blue" paint.

Prior to departing the facility, I documented that the blue paint used to paint garbage bins was a Sheboygan Paint Company brand, water based paint. The following photos document the identification of the paint utilized at the Republic Services facility:

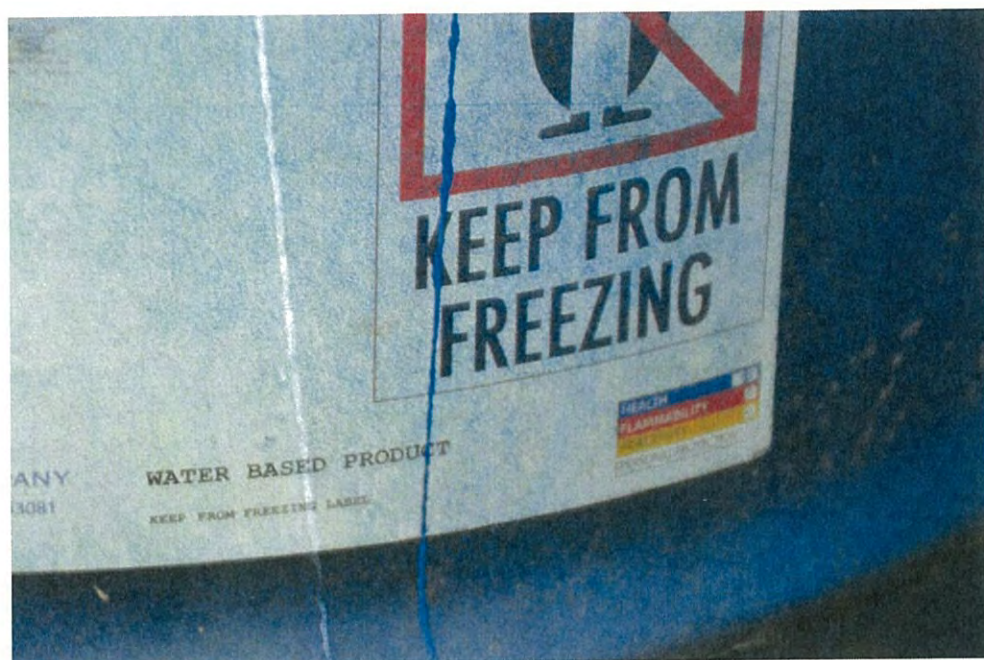
Figure 13 (DSC_8824): Paint identified as a water based product.

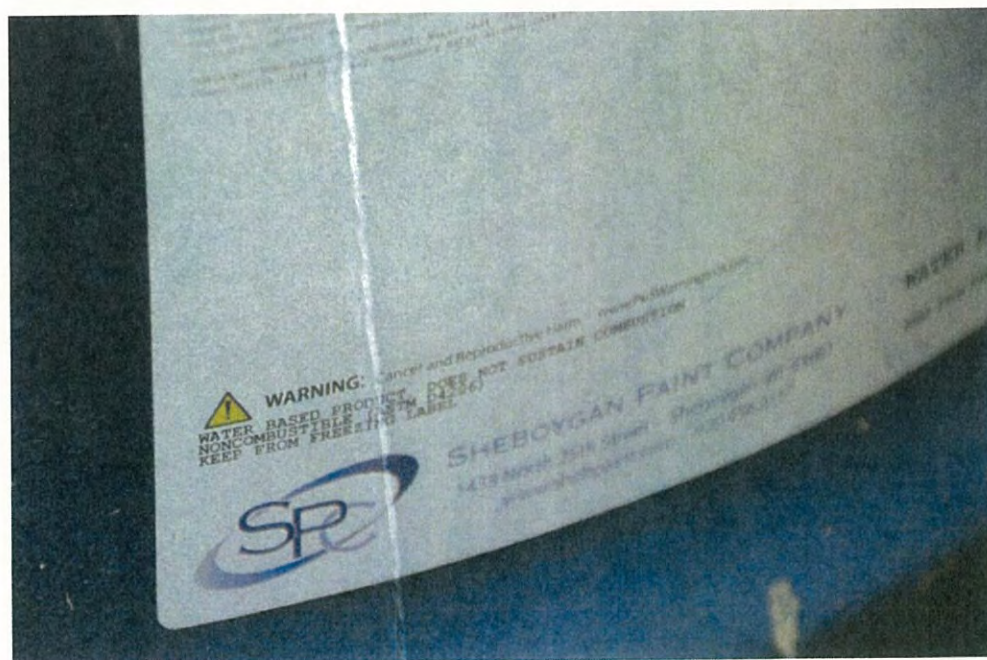
Figure 14 (DSC_8828): Paint identified as being a product of Sheboygan Paint Company.

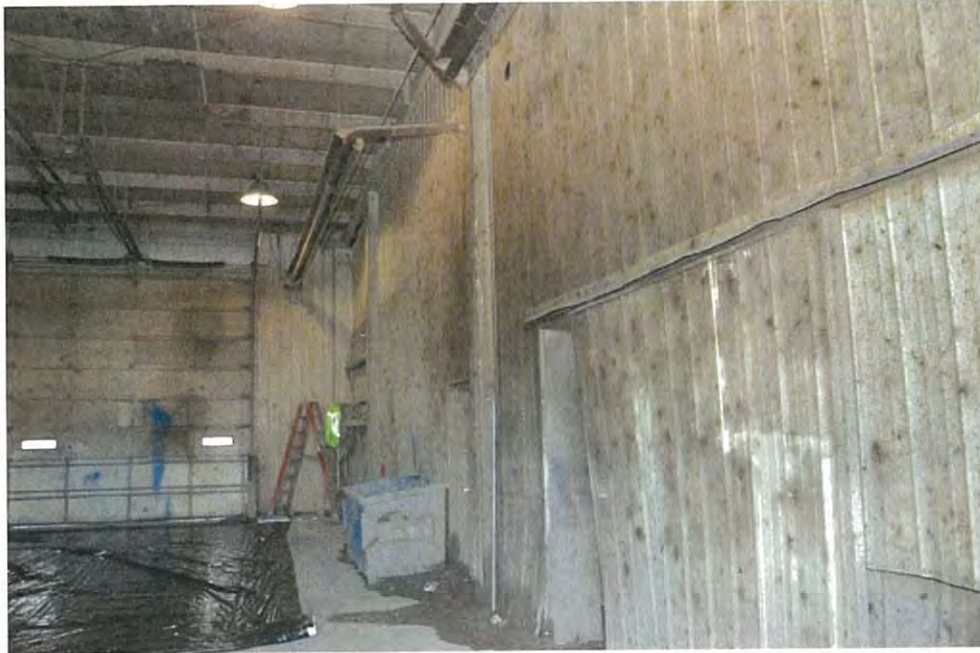
Figure 15 (DSC_8833: Area used as paint bay, since fire. Tube heaters still in use.

I also documented that paint operations had been moved into another building at the facility, where tube heaters were still being utilized.

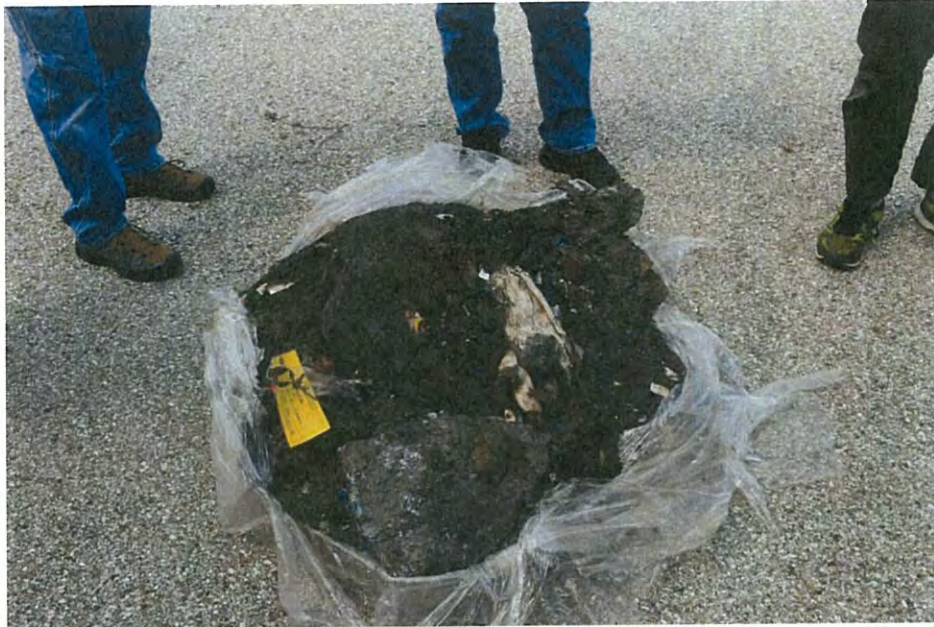
Figure 16 (DSC_9868): Photo of melted garbage container prior to excavation.

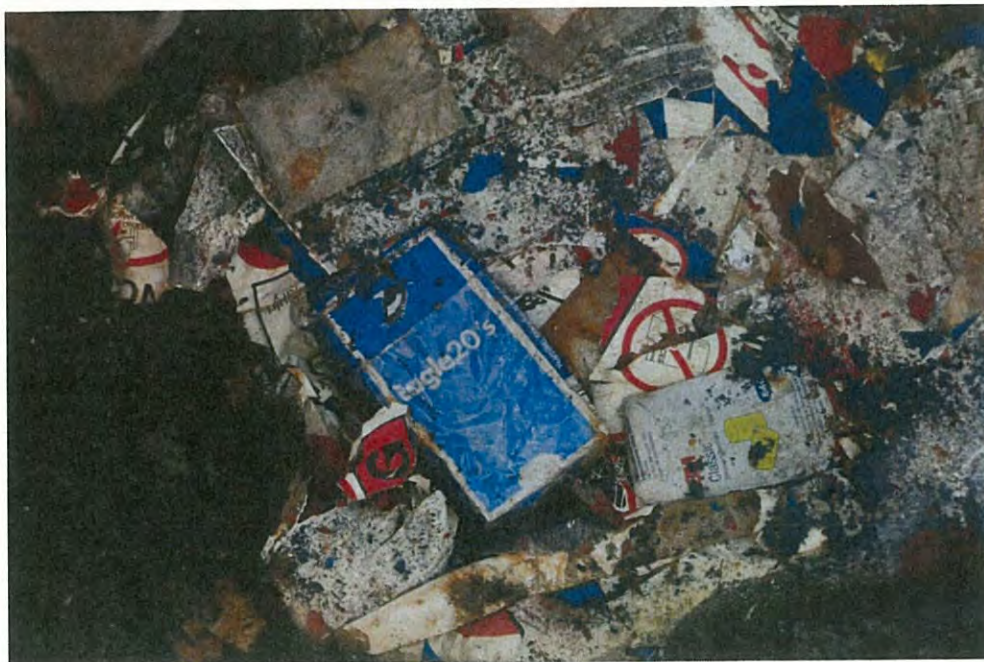
Figure 17 (DSC_9875): Photo of melted garbage container content remains to include discarded cigarette pack.

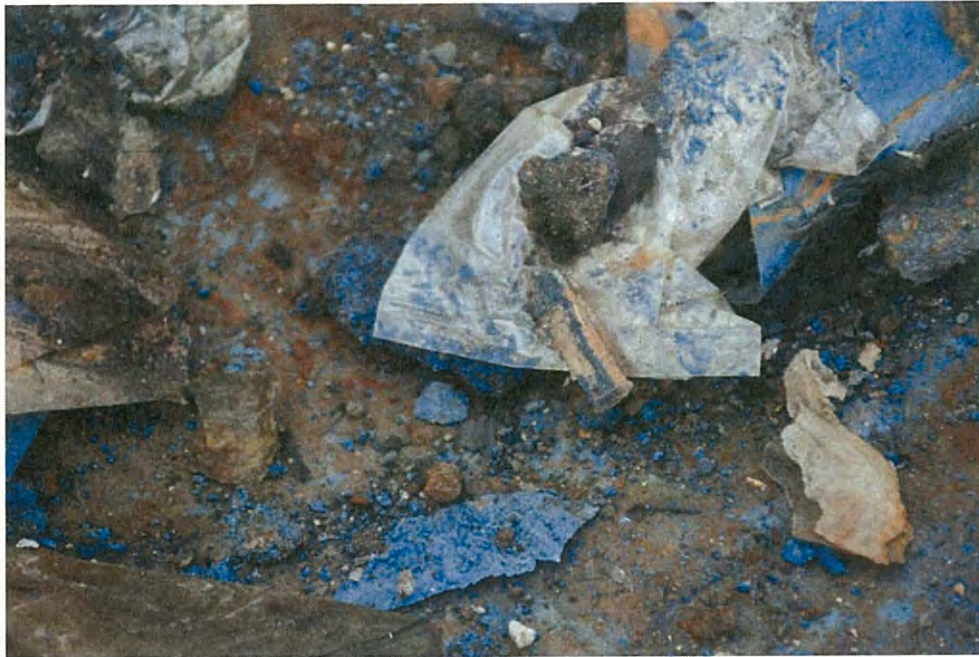
Figure 18 (DSC_9879): Photo of discarded cigarette butt among garbage container content remains.

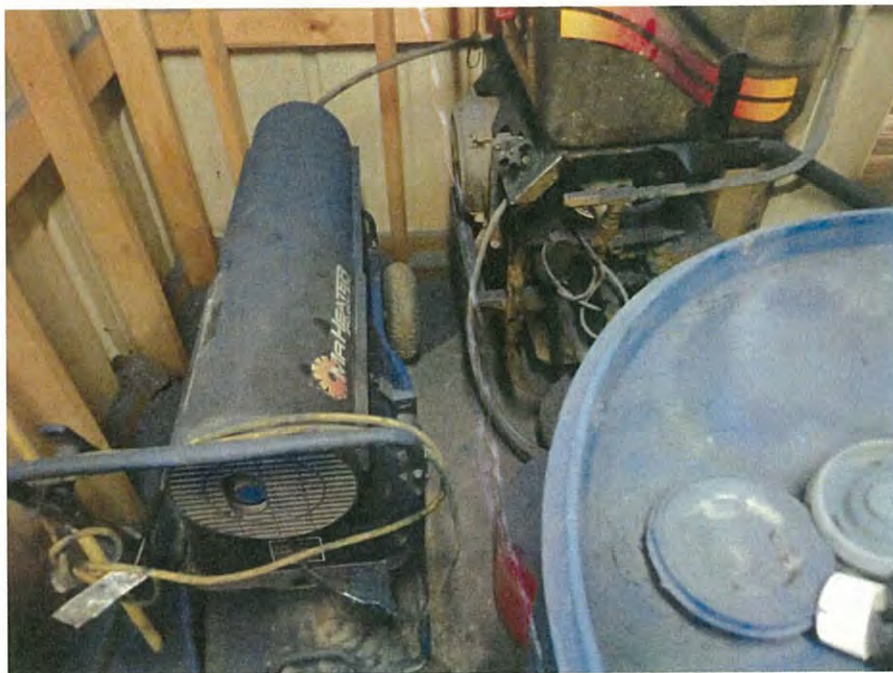
Figure 19: Rimkus photo P1010047 depicting a salamander heater, floor, and surrounding items covered in blue paint dust/overspray.

The below Rimkus photograph depicts the extent to which the salamander heater was covered in blue paint dust/overspray:

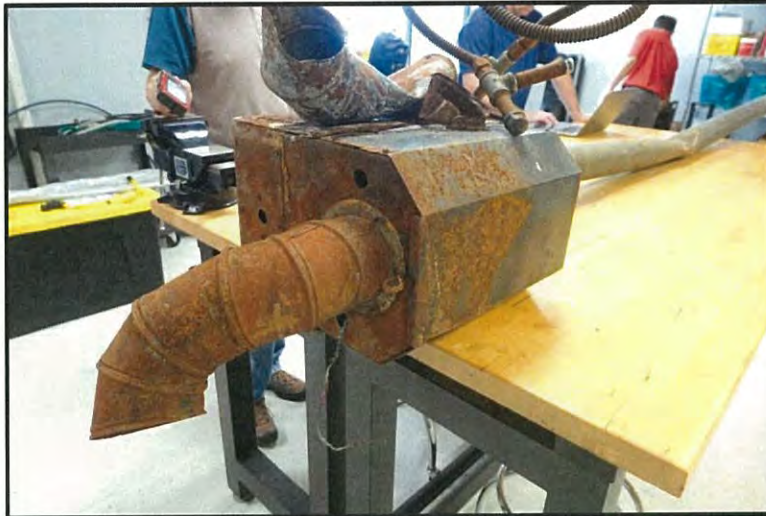
Figure 2 - MIDDLE Heater Remnants

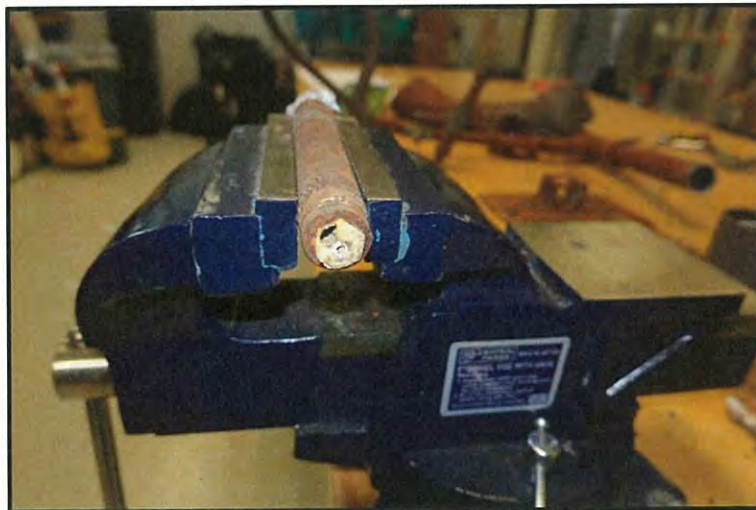
The brass LP gas jet was melted such that identification of orifice size could not be determined (**Figure 3**). The LP gas combination gas valve was a re-solidified pool of aluminum (**Figure 4**).

Figure 3 - Melted Brass Jet

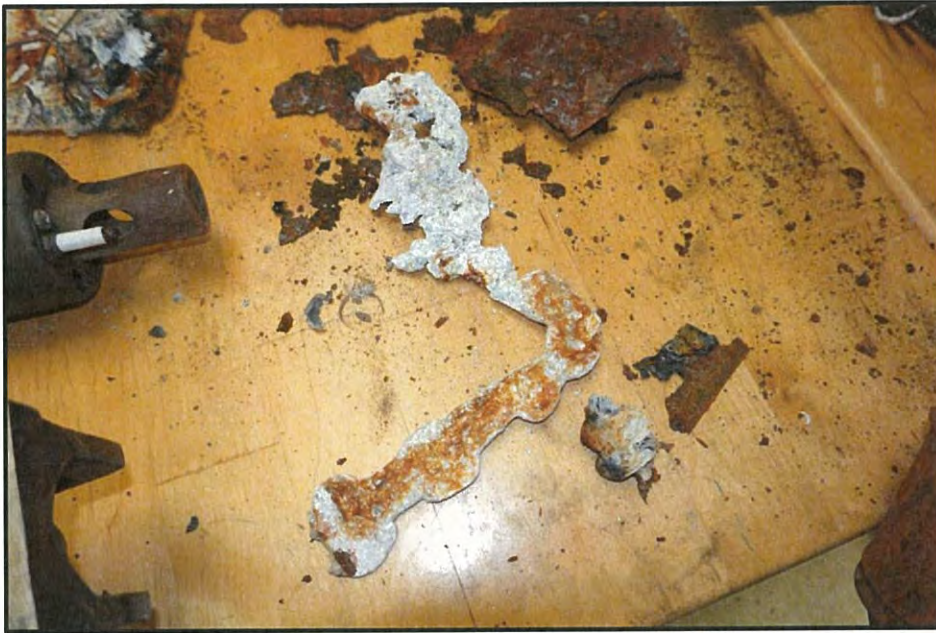
Figure 4 - LP Gas Combination Valve

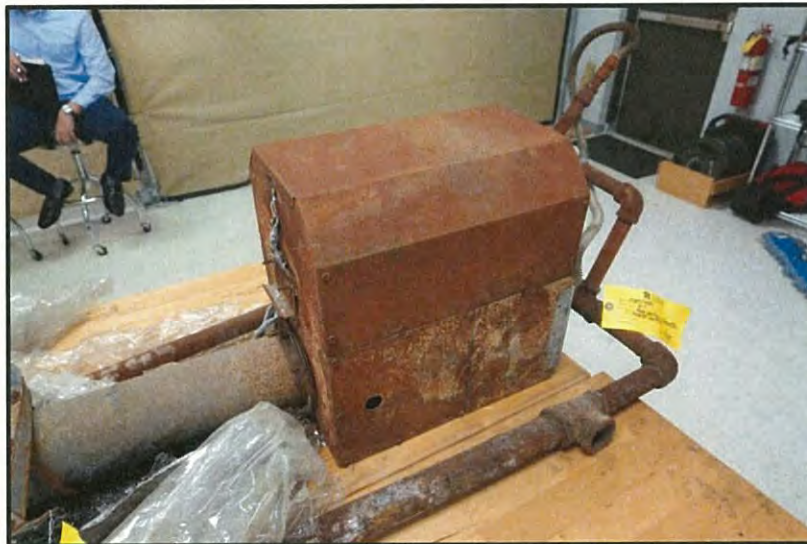
As shown in **Figure 12**, the NORTH Heater head was presented with a LP gas supply piping segment, appliance connector, and the starter collar/elbow segment for a single-wall intake (combustion air supply) duct. All items were damaged from the heat of the fire and/or building collapse. The LP gas combination valve body had melted (**Figure 13**).

Figure 12 - NORTH Heater Head with LP Gas Supply Piping

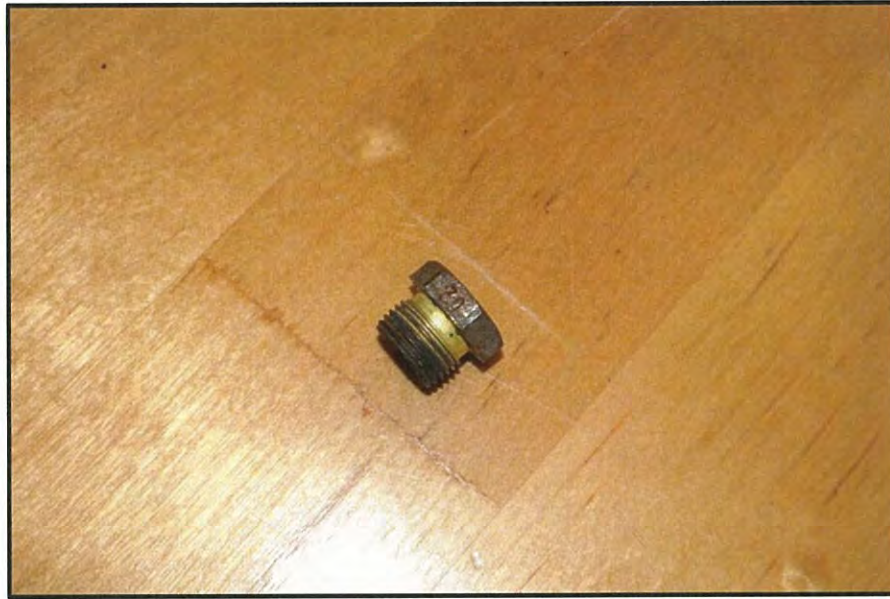
The brass LP gas orifice was recovered from the burner remnants. The heater was equipped with a proper drill size 30 LP gas orifice (**Figure 14**).

Figure 14 - NORTH Heater Orifice

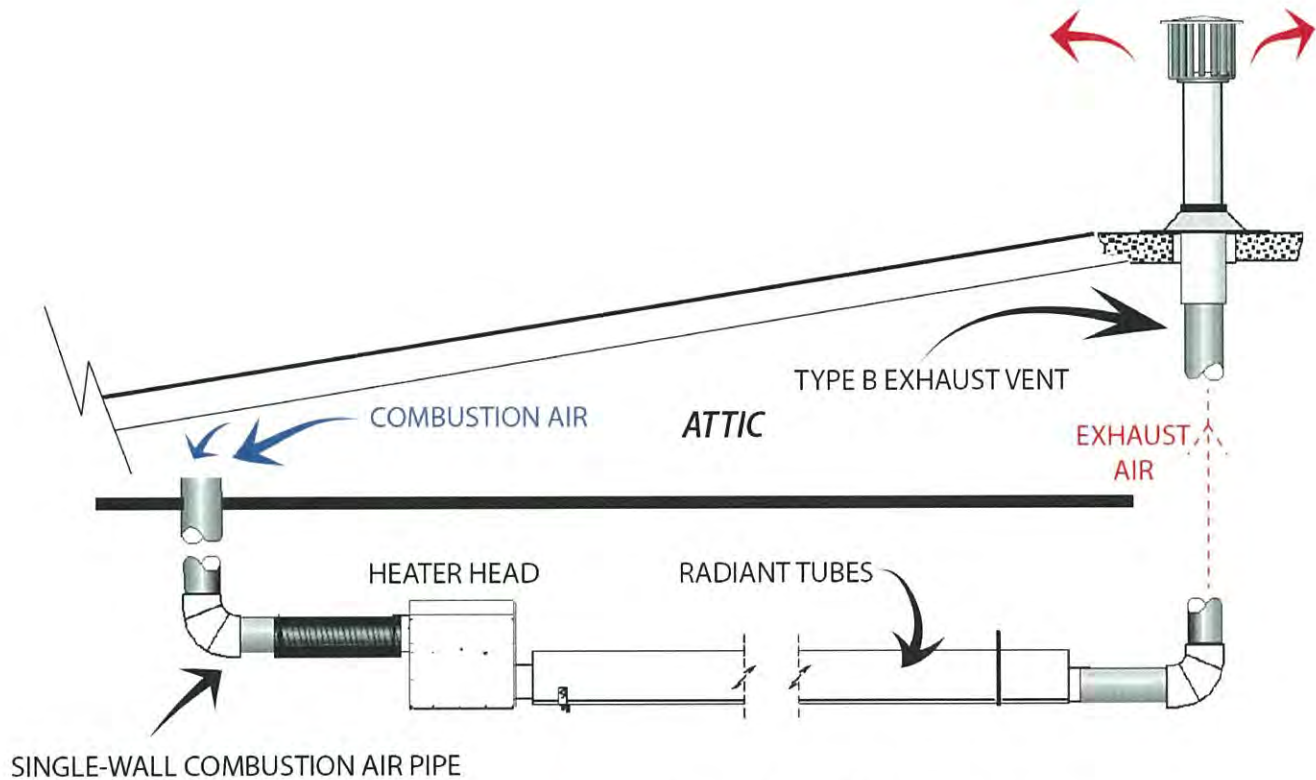
Figure 16 - Radiant Heater Direct-Vent Air Flow Paths
